TO : All Bidders
FROM : James P. DiCamillo
PROJECT : Rowland High School Additions/Renovations
Project 1310700.41
SUBJECT : Addendum 4
DSA : 03-115771 / 19-H54

ADDENDUM NO. 4

**ASBESTOS AND LEAD-BASED
PAINT INSPECTION REPORT**

The **ROWLAND UNIFIED SCHOOL DISTRICT** retained **ENCORP** to conduct an asbestos and lead-based paint inspection at the **ROWLAND HIGH SCHOOL** campus. The purpose of this inspection was to identify suspect Asbestos Containing Materials (ACM~~s~~) and Lead-Based Painted Materials (LBPM~~s~~) that may be impacted in the upcoming Improvements Project at the site. The inspection results that follow summarize the components tested, results, and recommendations anticipating impact during improvements Project. The inspection report represents updated inspection data for the planned demolition and renovation activities of Buildings C, F, G, H, J, M & P1-P27.

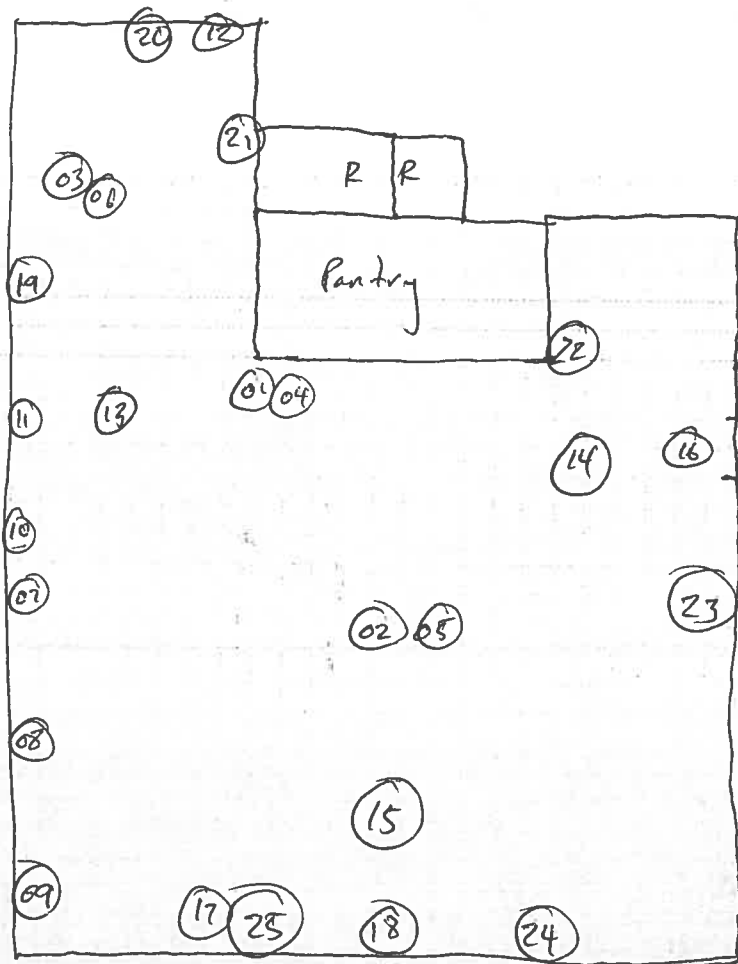
DESCRIPTION: ACM / LBP Survey
 JOB NAME: Rowland H.S. - Building J
 JOB NUMBER: P16146. R34
 DRAWN BY: Roberto Cisneros

Material Description	Locations	Individual Sq Ft	Total Sq Ft	Condition	Qty of Samples	Sample #'s
12x12 Ceiling Tile/ Mastic	① Building J Kitchen Interior		2200 D	G	3	1-3
Gypsum Ceiling Tile Board Ceiling			2200 D	G	3	4-6
Drywall / J.C. / Mud Drywall / Tape J.C. / Mud Tape Plaster / Lathe			300 D	G	3	7-9
Black Base board			50 D	D	3	10-12
9x9 Tan VCT Floor tile/ Mastic			2200 D	D	3	13-15
9x9 Red VCT Floor tile/ Mastic			80 D	G	3	16-18
Drywall / Joint Compound Plaster / Lathe			200 D	D G	7 3	19-24 25
